TEST REPORT	
Report Number	6208316B.50
Date of issue	2024-12-12
Total number of pages	42
DEKRA Branch	DEKRA Testing and Certification (Shanghai) Ltd.
Applicant's name	JA Solar Technology Co., Ltd.
Address	No.123 Xinxing Road, 055550 Ningjin County, Hebei Province, PEOPLE'S REPUBLIC of CHINA
Test specification:	
Standard	IEC 61215-2: 2021 IEC TS 63342: 2022
Test procedure	Client specified
Non-standard test method	N/A
Test Report Form No.	DEKRA Specified Test_1.0
Test Report Form(s) Originator	DEKRA Testing and Certification (Shanghai) Ltd.
Master TRF	2022-12-30
General disclaimer:	
The test results presented in this report relate only to the object tested. This report shall not be reproduced, except in full, without the written approval of the Testing Laboratory. This report does not entitle to carry any test mark.

Test item description :	Photovoltaic (PV) Module(s)	
Trademark :

Manufacturer	JA Solar Technology Co., Ltd.	
Model/Type reference :	JAM66D45-XXX/LB	
Ratings :	Refer to page 6	
Testing procedure and testing location:		
<input checked="" type="checkbox"/>	DEKRA Branch:	DEKRA Testing and Certification (Shanghai) Ltd.
Location/ address	No.16, Lane 1288, Luoning Road, Baosha

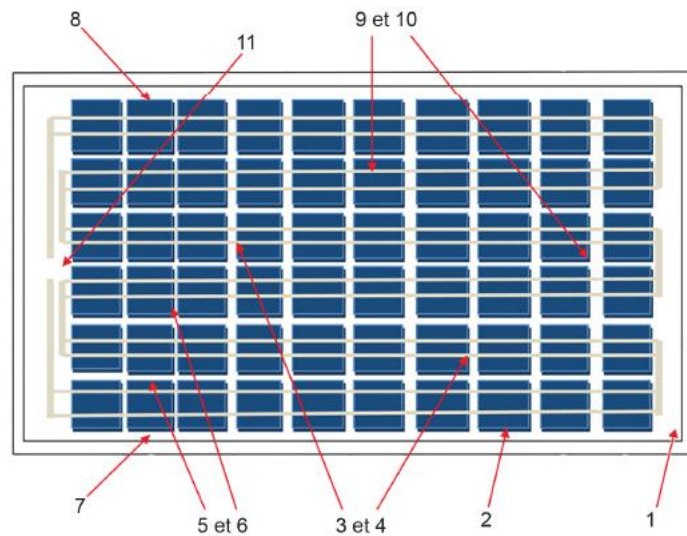
TABLE 06: MQT 17 - Hail impact test							
Test Date [YYYY-MM-DD].....:	2024-11-08						—
Sample #	2						—
Ice ball size [mm]	1	2	3	4	5	6	—
	35.2	35.2	35.3	35.3	35.0	35.4	
	7	8	9	10	11	—	
Ice ball weight [g]	1	2	3	4	5	6	—
	20.68	20.67	20.58	20.12	20.52	20.37	
	7	8	9	10	11	—	
Ice ball velocity [m/s].....:	1	2	3	4	5	6	—
	26.9	27.1	28.0	27.2	27.2	27.5	
	7	8	9	10	11	—	
Ice ball velocity [m/s].....:	28.1	27.3	27.3	27.4	27.5	—	
Number of impact locations	11						—

Supplementary information: (impact location descriptions)

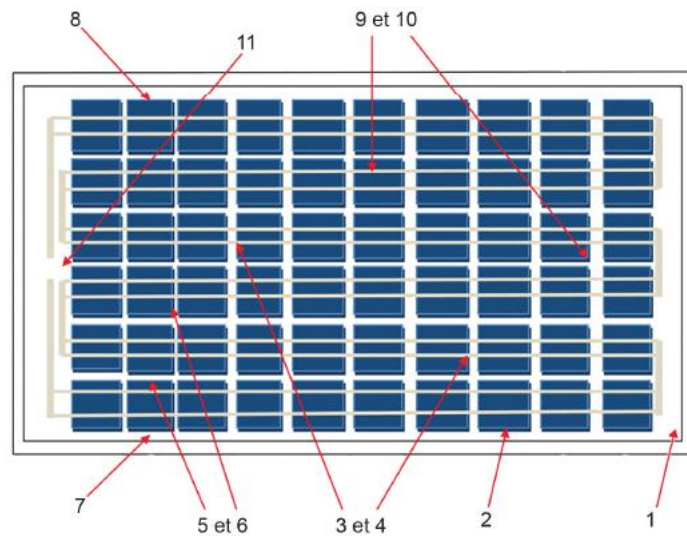
TABLE 06: MQT 17 - Hail impact test							
Test Date [YYYY-MM-DD].....:	2024-11-08						—
Sample #	3						—
Ice ball size [mm]	1	2	3	4	5	6	—
	35.0	35.1	35.0	35.0	35.2	35.5	
	7	8	9	10	11	—	
	35.2	35.0	35.2	35.4	35.3	—	
Ice ball weight [g]	1	2	3	4	5	6	—
	20.87	20.87	20.61	20.78	20.19	21.07	
	7	8	9	10	11	—	
	20.20	20.76	20.38	20.39	20.42	—	
Ice ball velocity [m/s].....:	1	2	3	4	5	6	—
	27.9	28.0	27.0	27.2	27.3	27.8	
	7	8	9	10	11	—	
	27.9	27.1	27.8	27.1	27.7	—	
Number of impact locations	11						—

Supplementary information: (impact location descriptions)

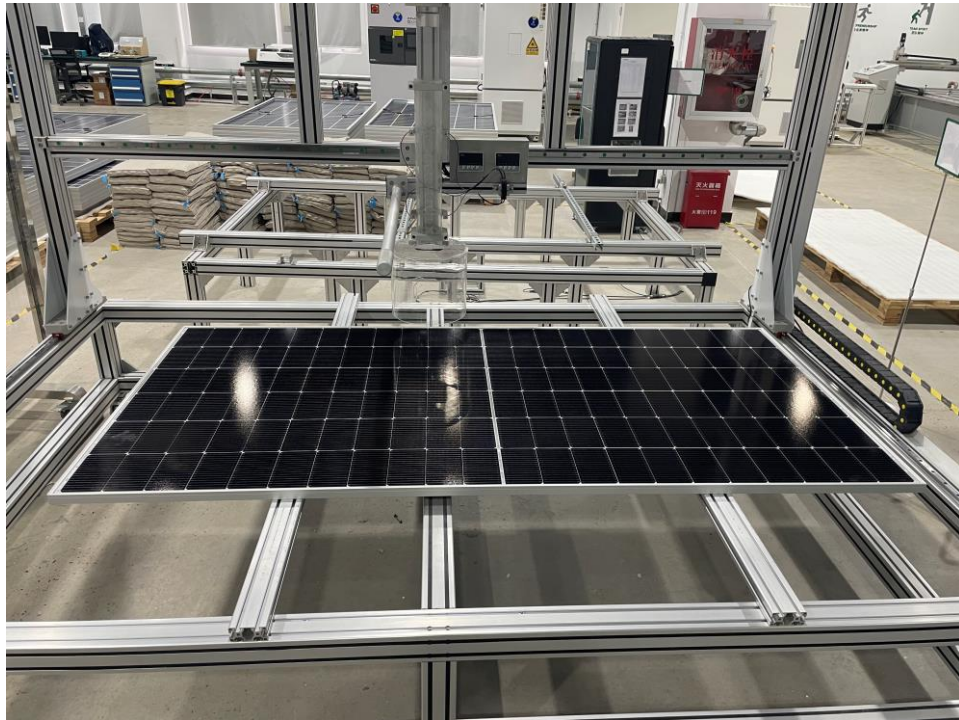
Fig. 6: HI test image of Sample No. 3

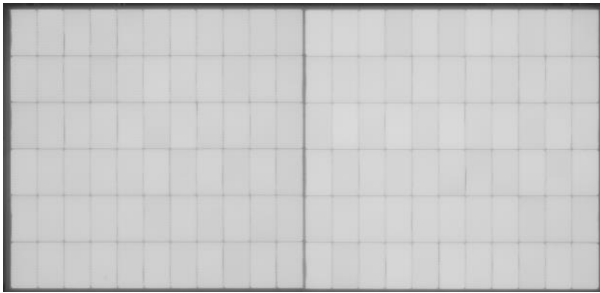
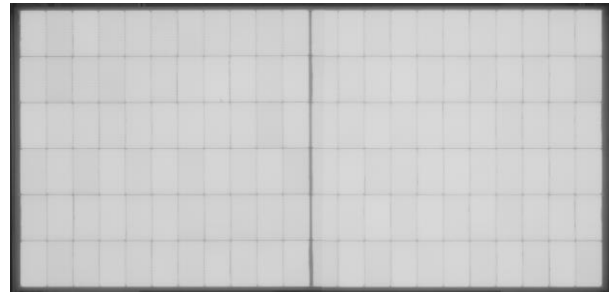
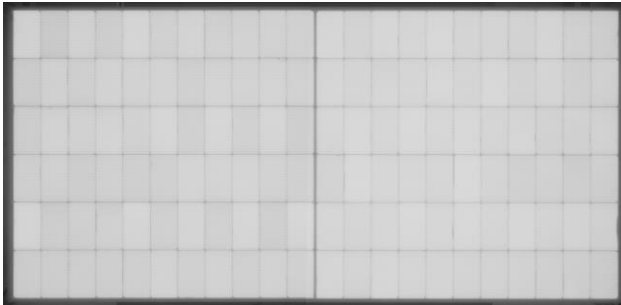
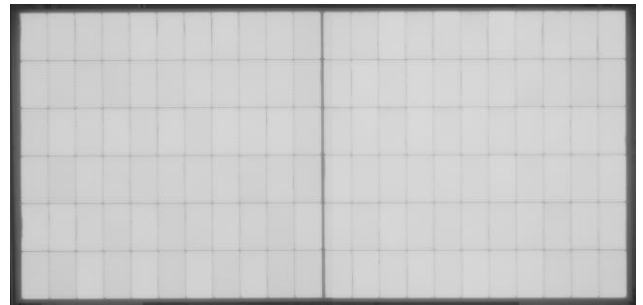
TABLE 05: Initial EL-images		
Test Date [YYYY-MM-DD]	2024-11-08	—
Current applied:	I _{sc}	—
Sample #	Remarks	—
1	No significant defects found.	—
2	No significant defects found.	—
3	No significant defects found.	—
4	No significant defects found.	—
5	No significant defects found.	—
6	No significant defects found.	—
7	No significant defects found.	—
8	No significant defects found.	—
9	No significant defects found.	—
10	No significant defects found.	—
11	No significant defects found.	—
Supplementary information: N/A

Fig. 7: Initial EL image(I_{sc}) of Sample No. 1

Fig. 8: Initial EL image(I_{sc}) of Sample No. 2

Fig. 9: Initial EL image(I_{sc}) of Sample No. 3

Fig. 10: Initial EL image(I_{sc}) of Sample No. 4

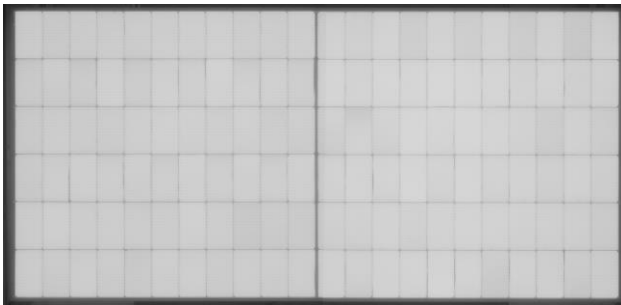
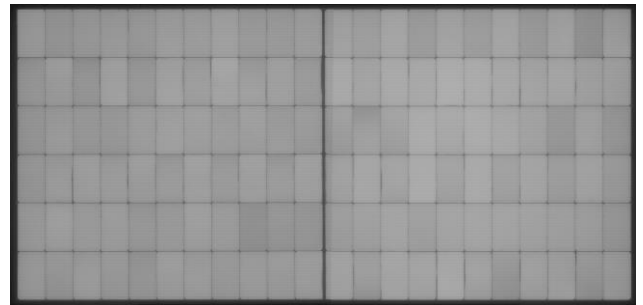
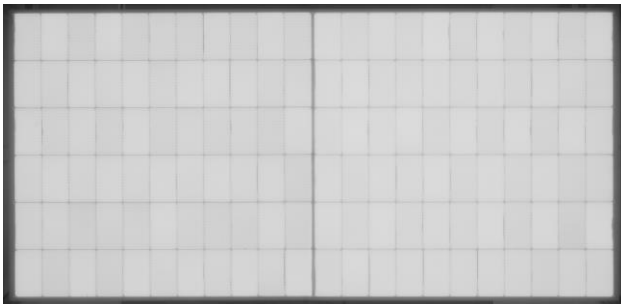
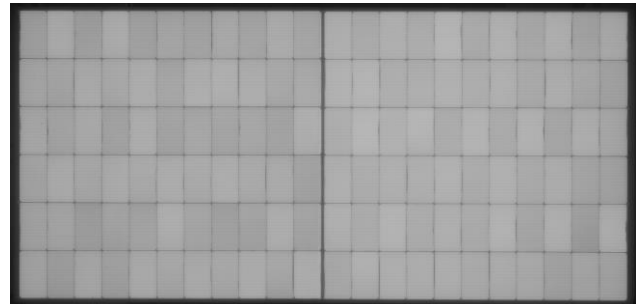
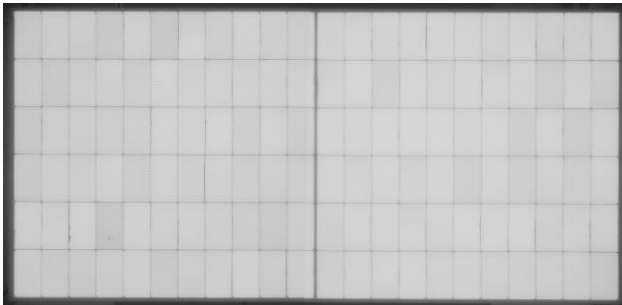
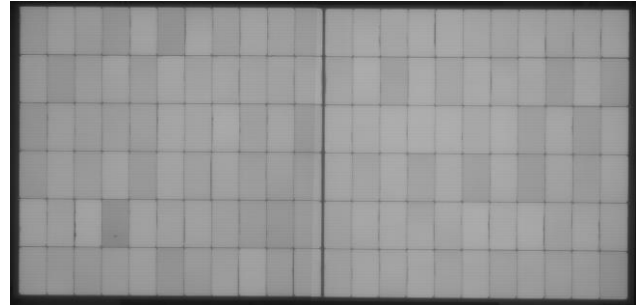
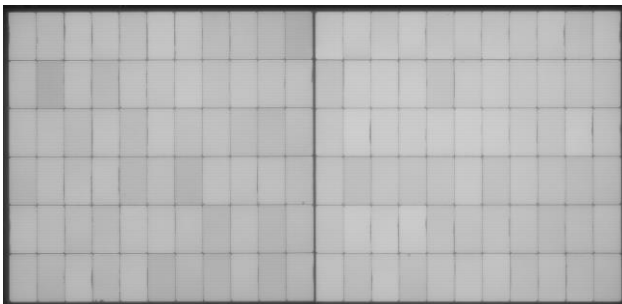
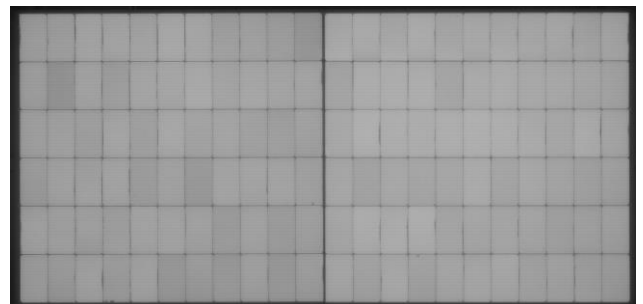
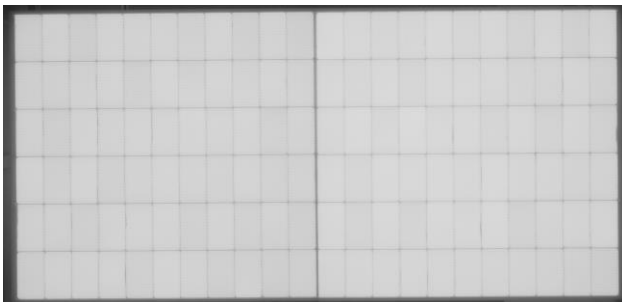
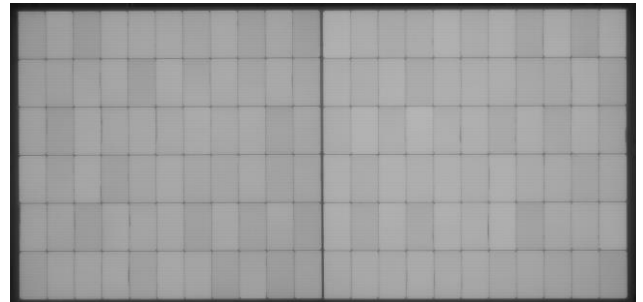
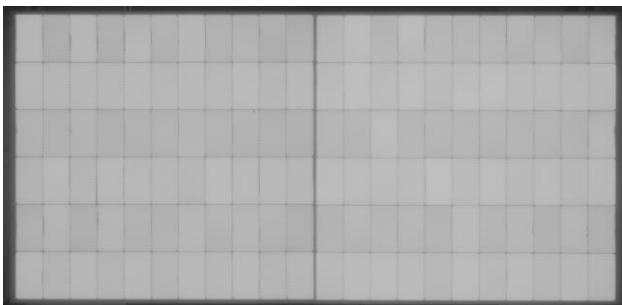
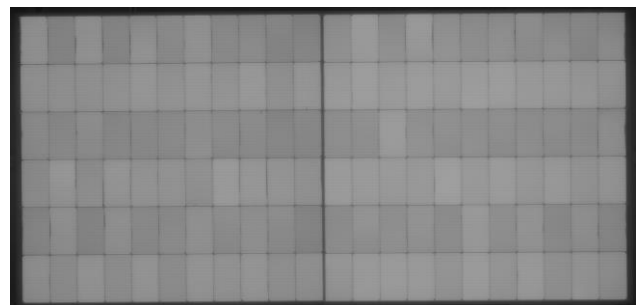
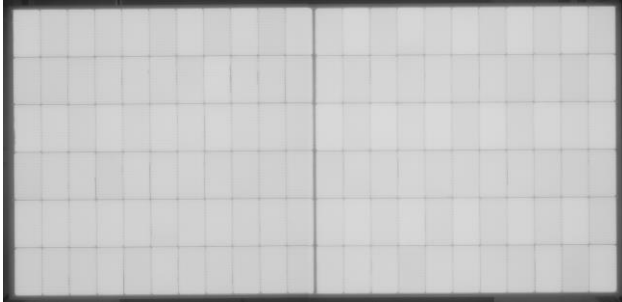
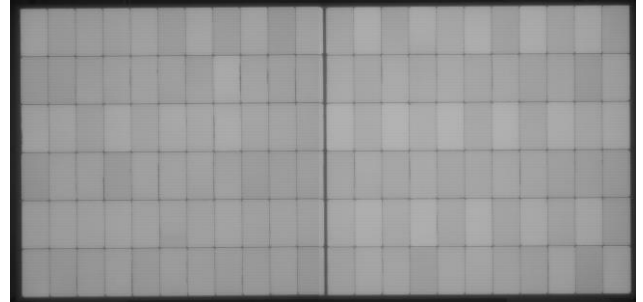
TABLE 07.7: EL-images after CID preconditioning			
Test Date [YYYY-MM-DD].....		2024-11-11	—
Current applied.....		I _{sc}	—
Sample	Remarks		
6	No significant defects found.		—
7	No significant defects found.		—
8	No significant defects found.		—
9	No significant defects found.		—
10	No significant defects found.		—
11	No significant defects found.		—
Supplementary information: N/A

Fig. 11: EL image(I_{sc}) after CID of Sample No. 5

Fig. 13: EL image(I_{sc}) after CID of Sample No. 6

Fig. 15: EL image(I_{sc}) after CID of Sample No. 7

Fig. 17: EL image(I_{sc}) after CID of Sample No. 8

Fig. 19: EL image(I_{sc}) after CID of Sample No. 9

Fig. 21: EL image(I_{sc}) after CID of Sample No. 10

Fig. 23: EL image(I_{sc}) after CID of Sample No. 11

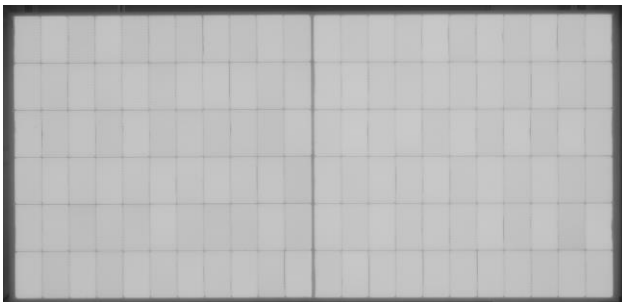
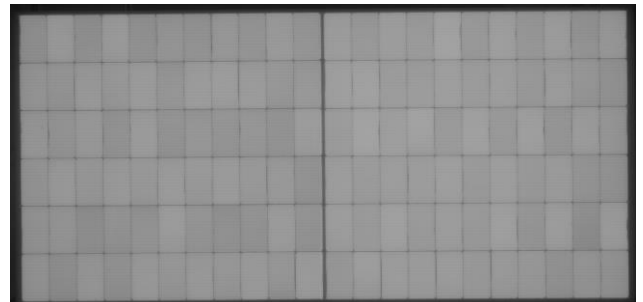
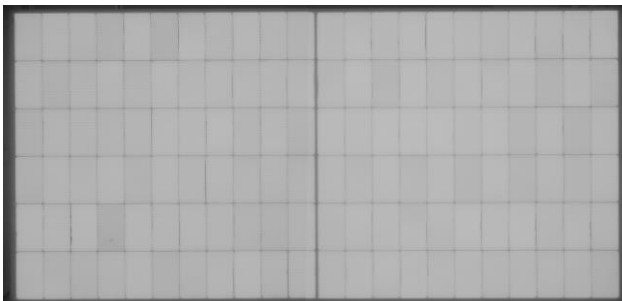
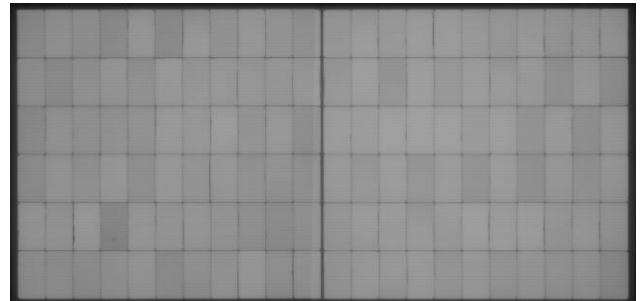
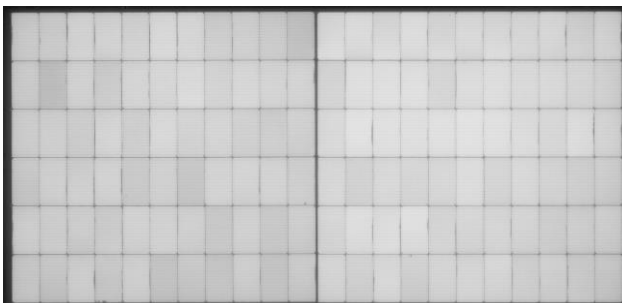
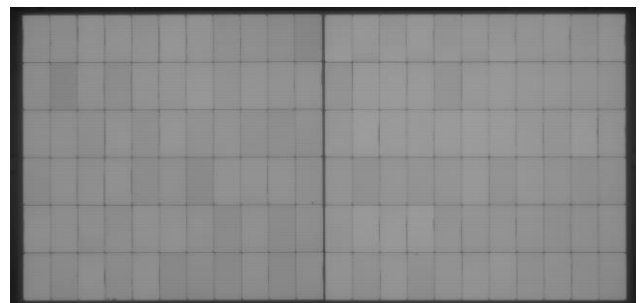
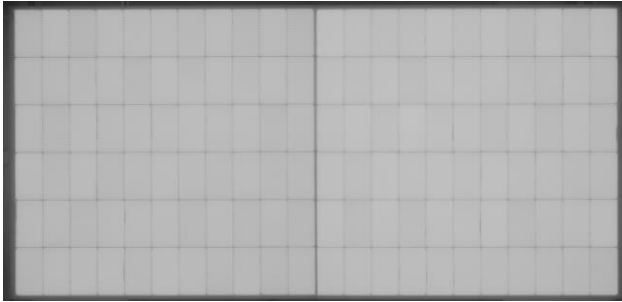
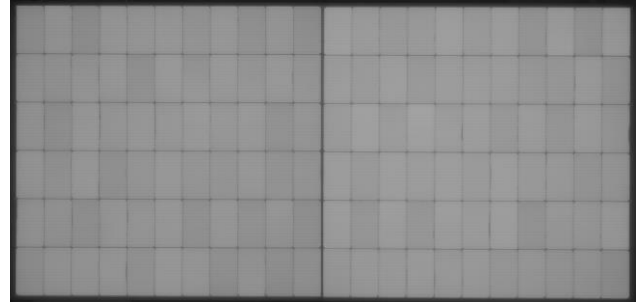
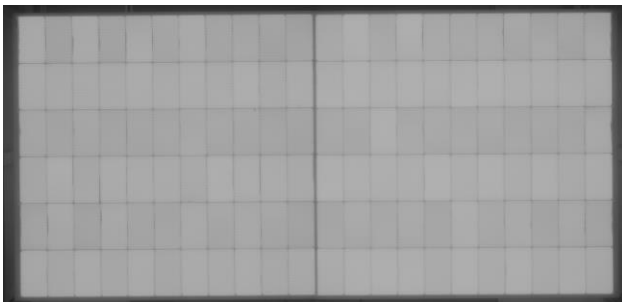
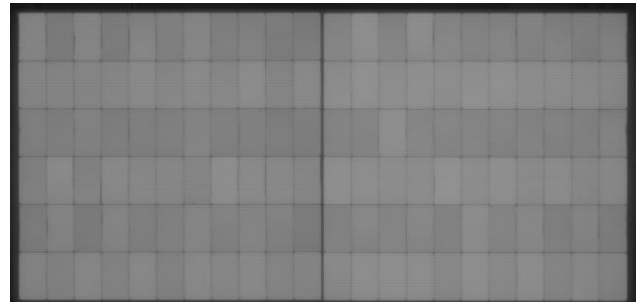
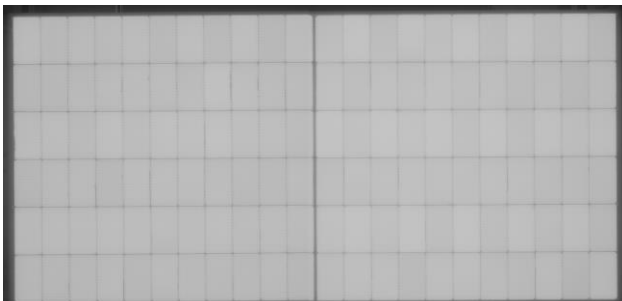
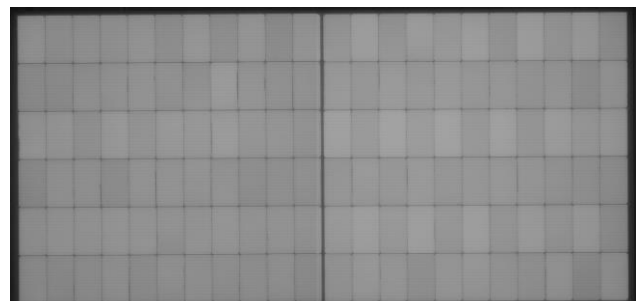
TABLE 08.7: EL-images after 1st LETID Detection			
Test Date [YYYY-MM-DD].....		2024-11-18	—
Current applied.....		0.1I _{sc} & I _{sc}	—
Sample	Remarks		
6	No significant defects found.		—
7	No significant defects found.		—
8	No significant defects found.		—
9	No significant defects found.		—
10	No significant defects found.		—
11	No significant defects found.		—
Supplementary information: N/A

Fig. 25: EL image(I_{sc}) after 1st LeTID of Sample No. 6

Fig. 27: EL image(I_{sc}) after 1st LeTID of Sample No. 7

Fig. 29: EL image(I_{sc}) after 1st LeTID of Sample No. 8

Fig. 31: EL image(I_{sc}) after 1st LeTID of Sample No. 9

Fig. 33: EL image(I_{sc}) after 1st LeTID of Sample No. 10

Fig. 35: EL image(I_{sc}) after 1st LeTID of Sample No. 11

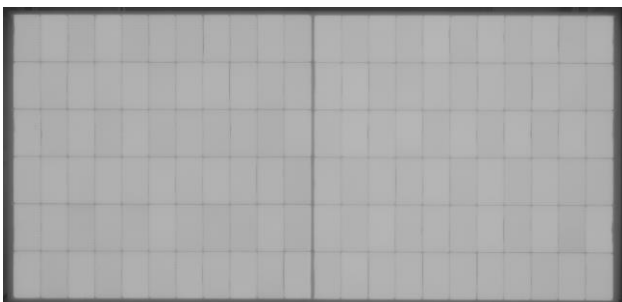
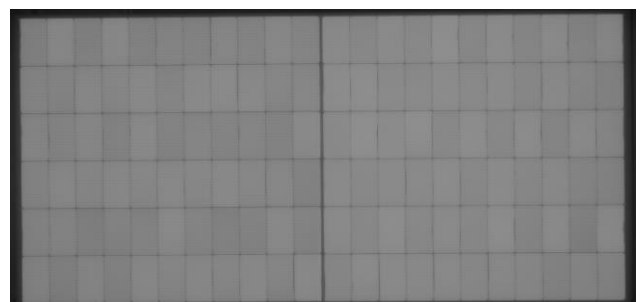
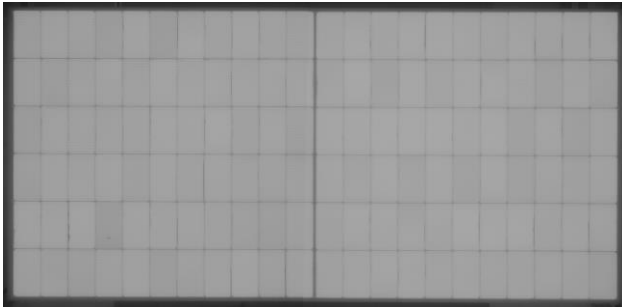
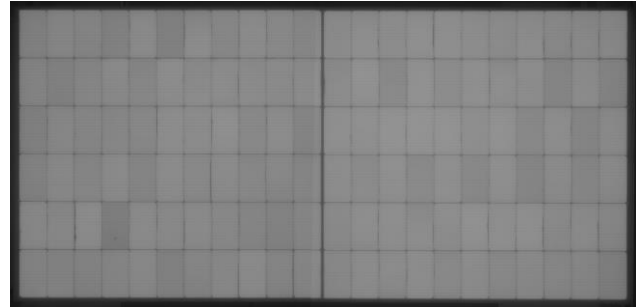
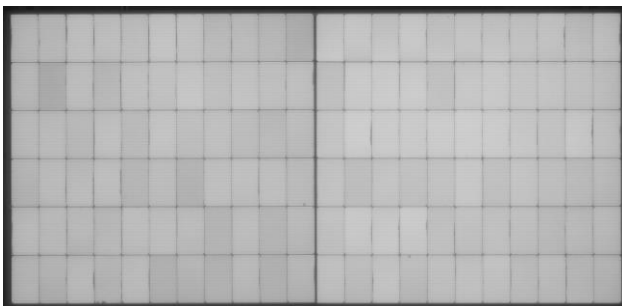
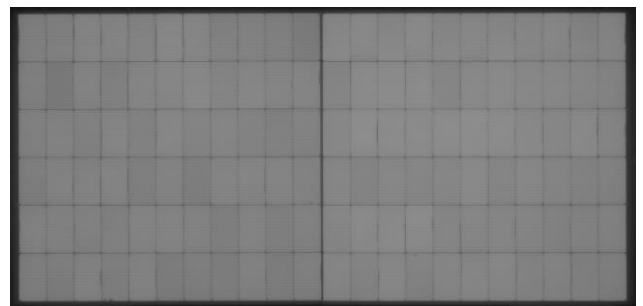
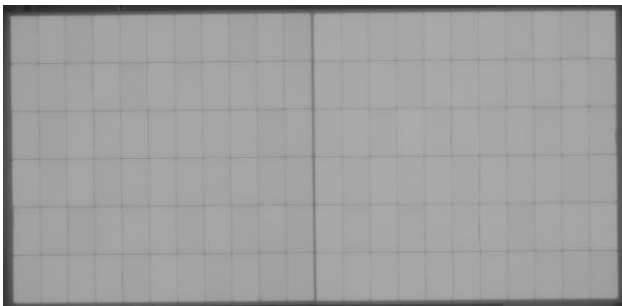
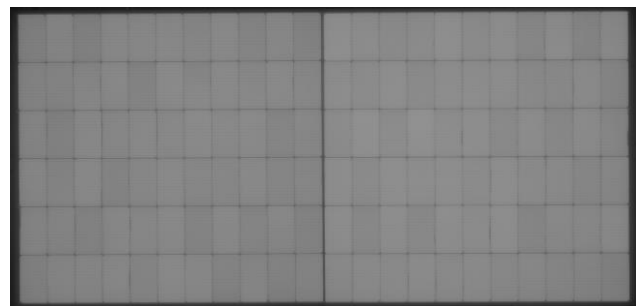
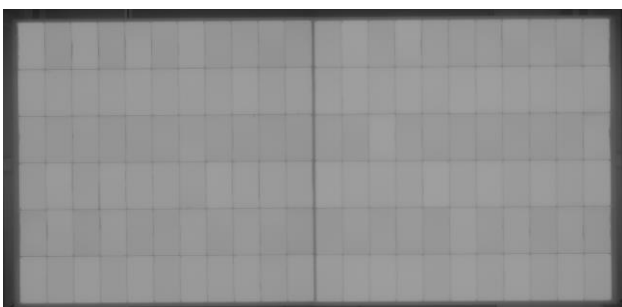
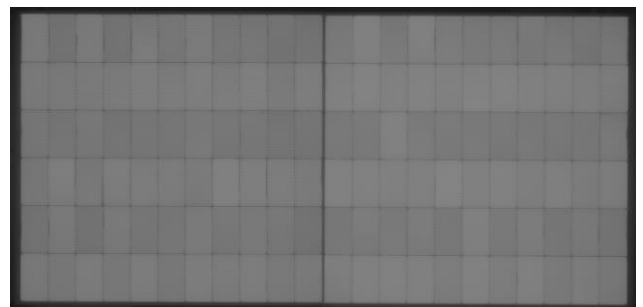
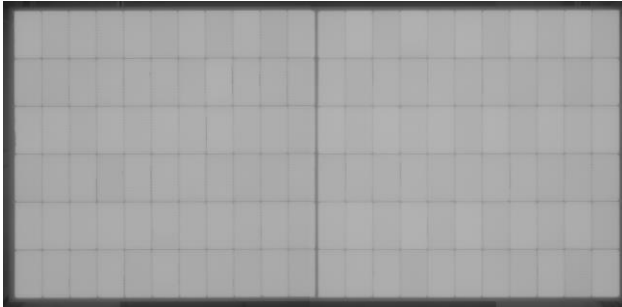
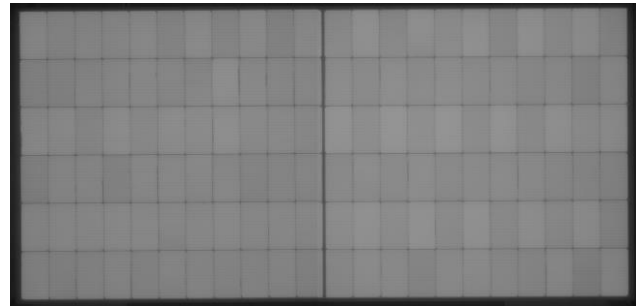
Fig. 37: EL image(I_{sc}) after 2nd LeTID of Sample No. 6

Fig. 39: EL image(I_{sc}) after 2nd LeTID of Sample No. 7

Fig. 41: EL image(I_{sc}) after 2nd LeTID of Sample No. 8

Fig. 43: EL image(I_{sc}) after 2nd LeTID of Sample No. 9

Fig. 45: EL image(I_{sc}) after 2nd LeTID of Sample No. 10

Fig. 47: EL image(I_{sc}) after 2nd LeTID of Sample No. 11

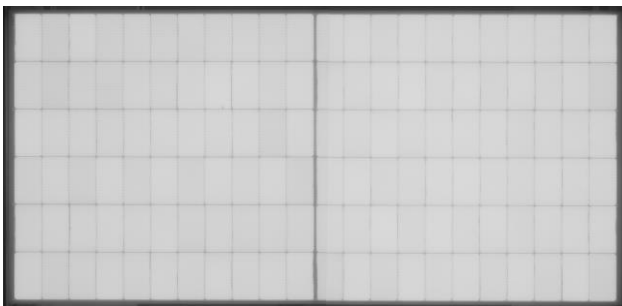
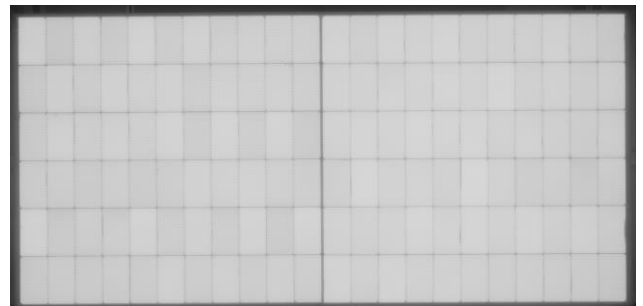
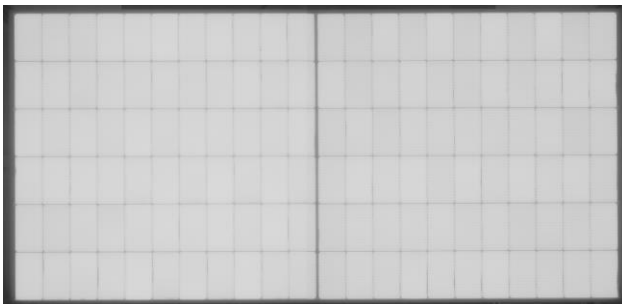
TABLE 06.7: EL-images after Hail impact test		
Test Date [YYYY-MM-DD]..... :	2024-11-08	—
Current applied..... :	I _{sc}	—
Sample	Remarks	
2	No significant defects found.	—
3	No significant defects found.	—
4	No significant defects found.	—
Supplementary information: N/A

Fig. 49: EL image after HI of Sample No. 2

Fig. 50: EL image after HI of Sample No. 3

Fig. 51: EL image after HI of Sample No. 4
