Test Report

Photovoltaic Module Tests
according to Client's Requirements

TÜV Report No. CN25N73T 002

Module manufacturer	Tongwei Co.,Ltd.
Module type	TWMNF-66HD710
Module technology	½ cut n-TOPCon c-Si cell Bifacial Module, 132 pcs

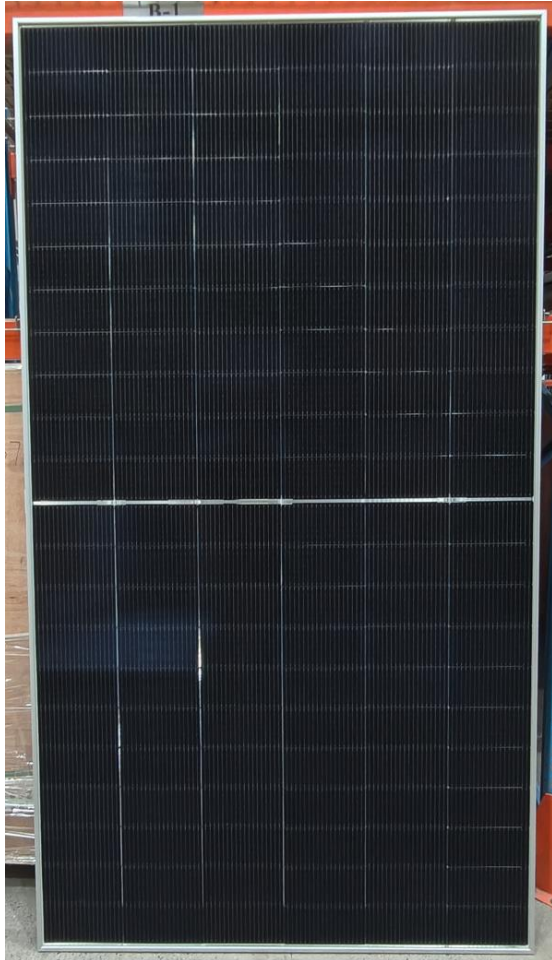
Figure 1: Front view of test module type TWMNF-66HD710

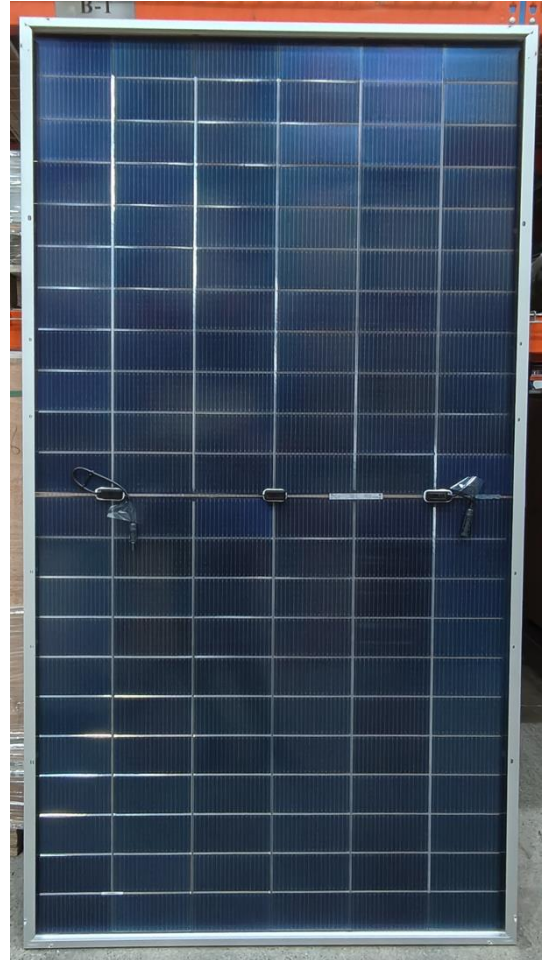
Figure 2: Rear view of test module type TWMNF-66HD710

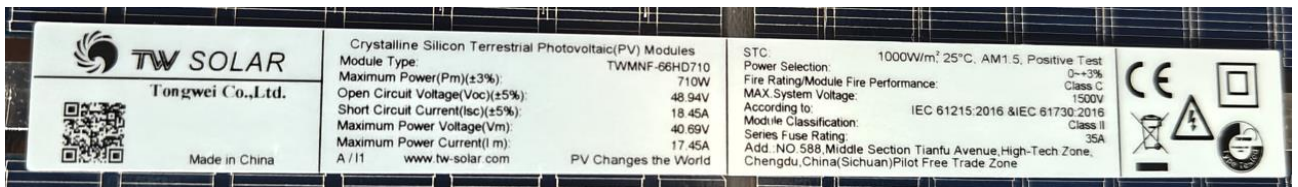
Figure 3: Rating label of test module type TWMNF-66HD710

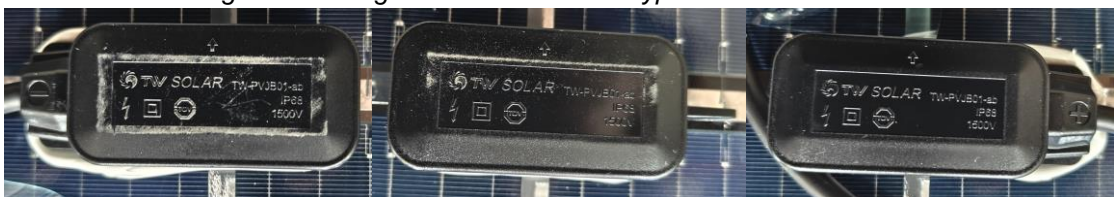
Figure 4: Junction boxes of test module type TWMNF-66HD710

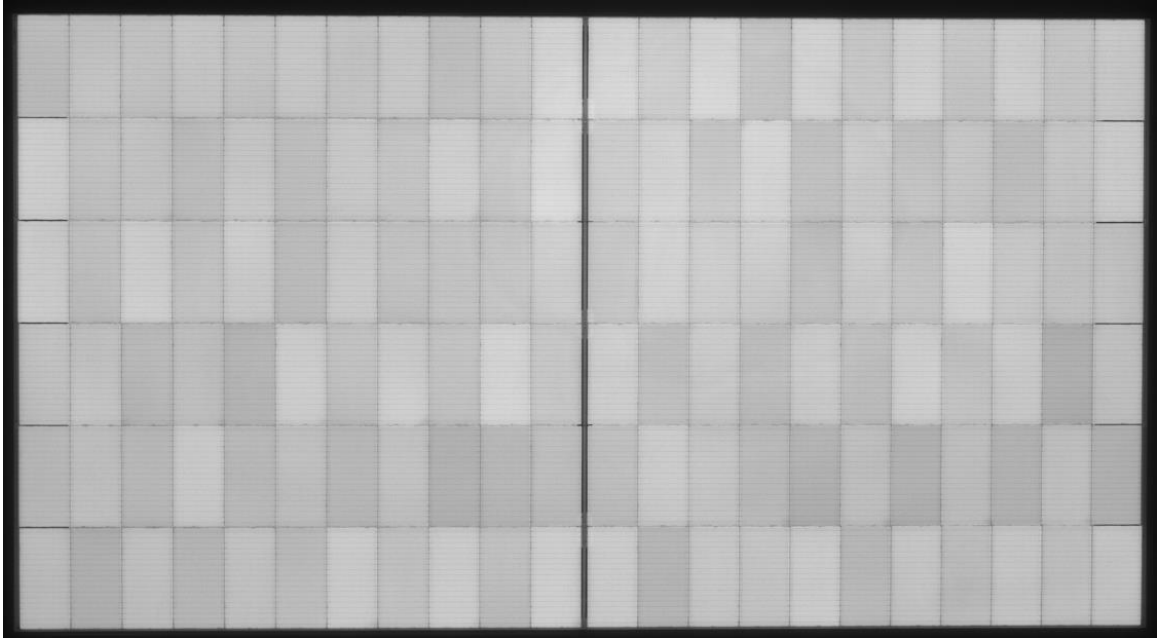
Figure 5: EL-image of sample #1 (initial)

The test sample is installed in a dark tunnel to prevent light entering the test area or reaching the test sample. A current close to the sample's rated I_{sc} for around 40 seconds is injected and then the EL image taken.

Test date [DD/MM/YYYY]	20/03/2025	
Current applied	I _{sc} ± 5%	
Sample #	Remarks	
1	N/A	
Supplementary information: Refer to Annex 2: EL-imaging.

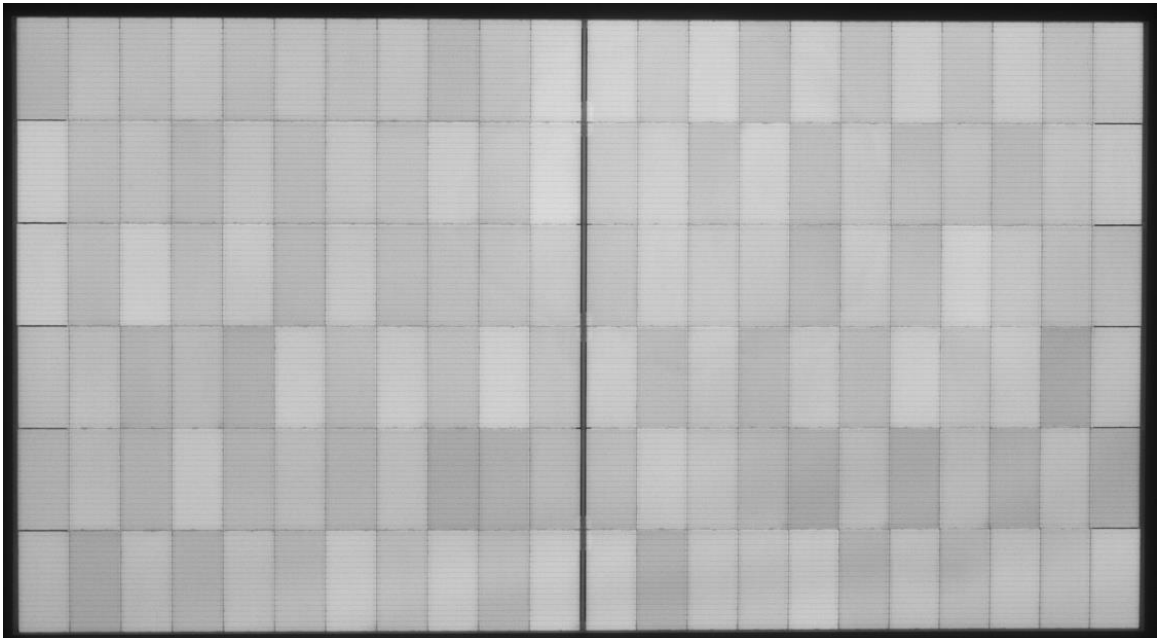
Figure 6: EL-image of sample #1 (after HI test)

Test date [DD/MM/YYYY]	26/03/2025		
Ice ball diameter [mm]	35		
Ice ball mass [g]	20.7 ± 2 %		
Ice ball velocity [m/s]	27.2 ± 5 %		
Number of impact locations	11		
Sample #	—		Verdict
1	—		P
Supplementary information: N/A.

Test date [DD/MM/YYYY]	26/03/2025
Current applied	Isc \pm 5%
Sample #	Remarks
1	N/A
Supplementary information: Refer to Annex 2: EL-imaging.
