## Untersuchungsbericht / Investigation Report A110062-8

**Probenbeschreibung /  
Description of sample/s:** Q-PEAK

**Prüfspezifikation /  
Test specification:** Noxious gas test in accordance with DIN EN 60068-2-43, DIN EN 60068-2-60  
Single gas test **NH<sub>3</sub>**  
Concentration: (750 ± 5) ppm,  
Duration: 10 days  
Temperature: (40 ± 1)°C  
Humidity: (75 ± 2)%

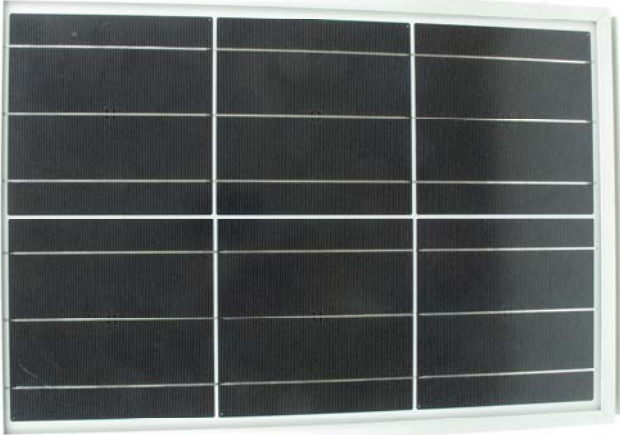
<p>Photo 1</p>

Probenbeschreibung / sample denomination	Technolab's Prüflings-Nr. / Technolab sample no.	Proben / Samples
<p>Q.PEAK ML14807 ML14808</p>	<p>110062-NH3 110062-NH3</p>

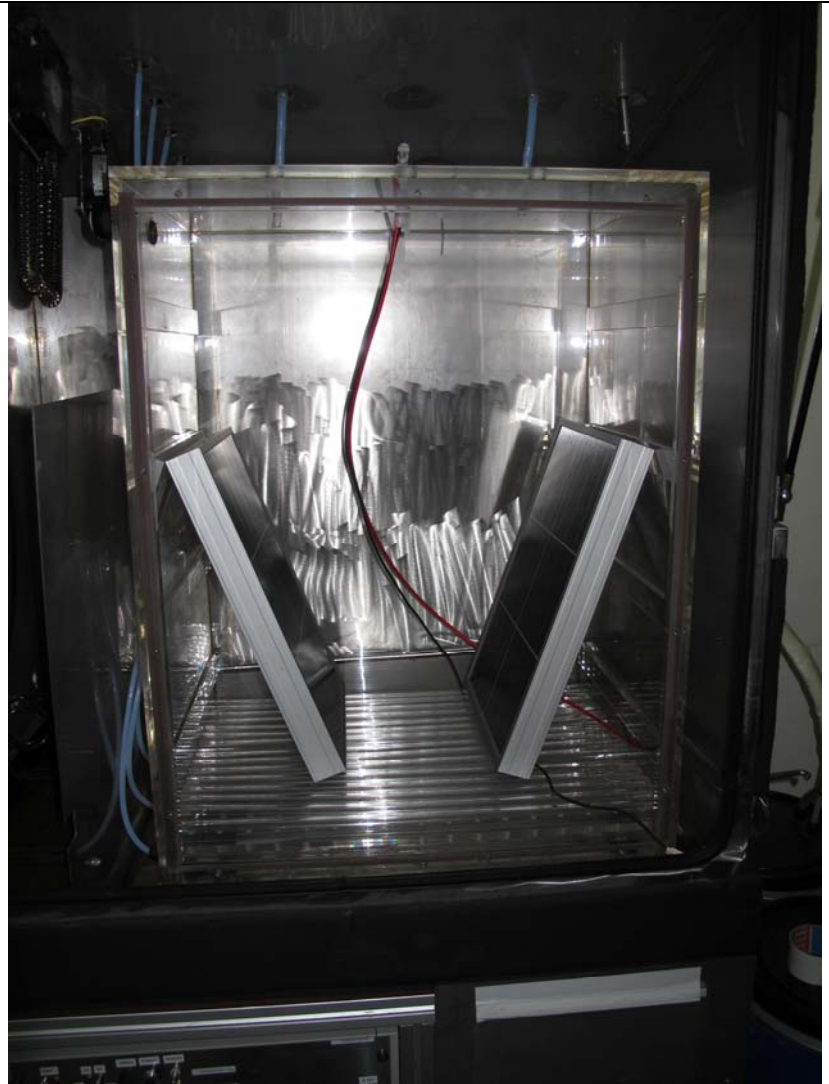
Foto 3

All samples in the noxious gas test chamber before the test.

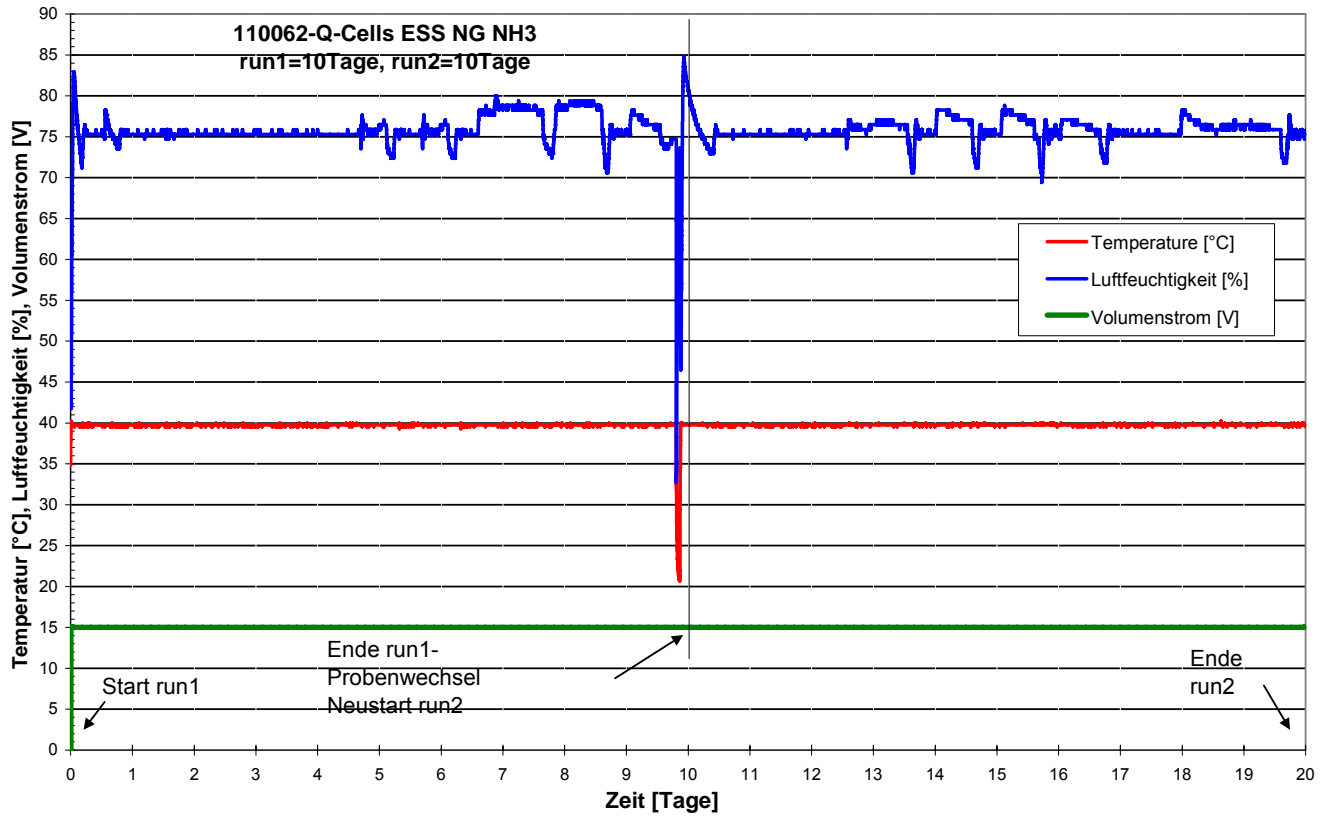
Diagram 1

Test parameters	
Test temperature	$(40 \pm 1)^\circ\text{C}$
Noxious gas concentration	$\text{NH}_3 = (750 \pm 5) \text{ ppm}$
Relative humidity	$(75 \pm 2)\%$
Test duration	10 days
