## Test Report No. TRPVP12119/24P/01

Commission Testing  
according to IEC 61215-2 / EN IEC 61215-2

Applicant..... :	<b>Tongwei Co., Ltd.</b> No. 588, Middle Section Tianfu Avenue, High-Tech Zone, Chengdu, China (Sichuan) Pilot Free Trade Zone
Manufacturer..... :	<b>Tongwei Co., Ltd.</b> No. 588, Middle Section Tianfu Avenue, High-Tech Zone, Chengdu, China (Sichuan) Pilot Free Trade Zone
Factory..... :	<b>Tongwei Solar (Hefei) Co., Ltd.</b> No.888, Changning Road, High-tech District, Hefei City, Anhui Province, 230088, P.R. China
Order No. .... :	QT-PVP12119/24P
Date of Application..... :	2024-12-23
Product..... :	Crystalline Silicon Terrestrial Photovoltaic (PV) Modules
Module type(s)..... :	<b>PV Modules:</b> TWMNH-48HW450/ TWMNH-48HE445
General Information

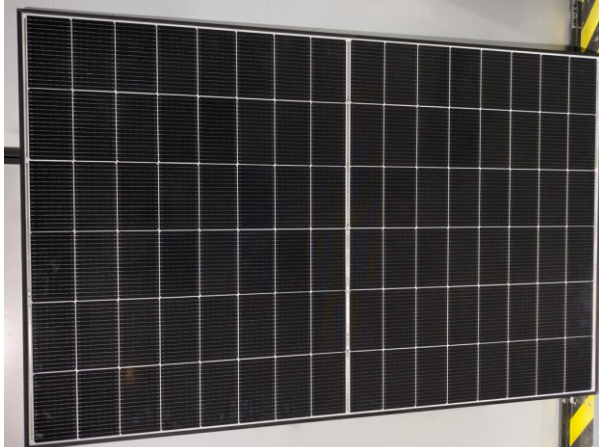
*Front overview*

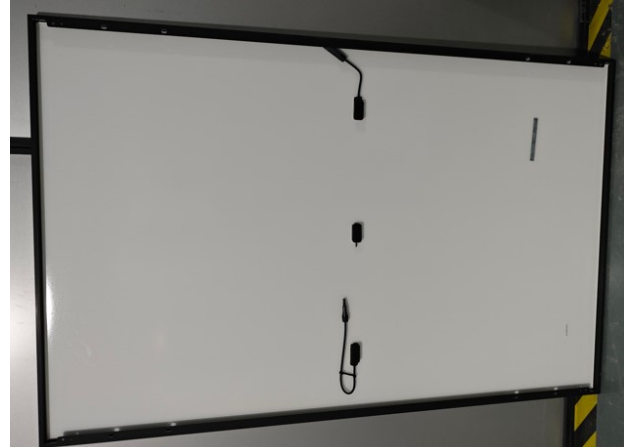
*Back overview*

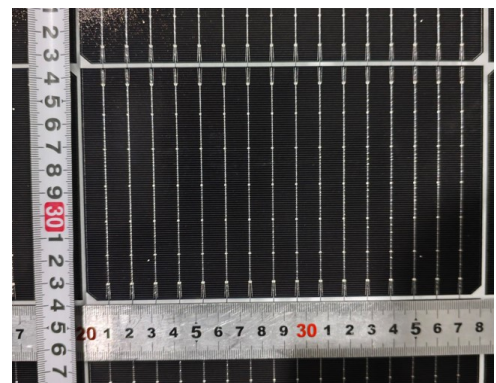
*Solar cell*

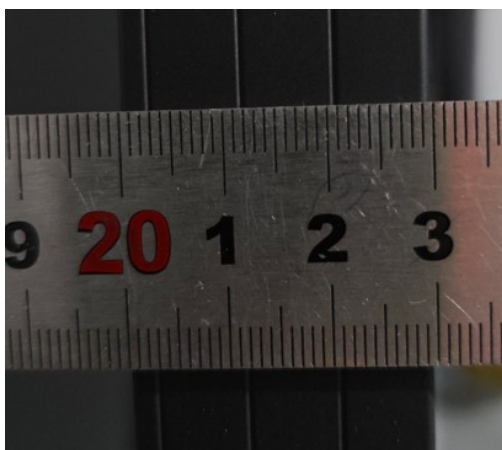
*Frame*

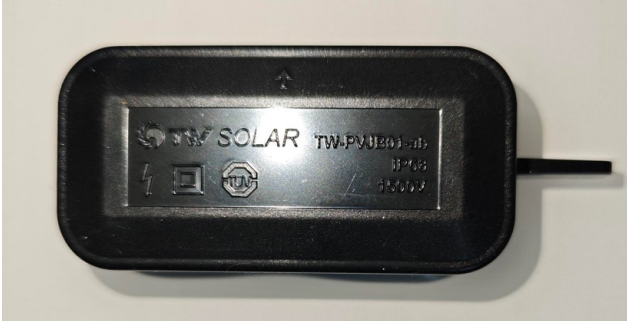
*Junction box (TW-PVJB01-ab)*

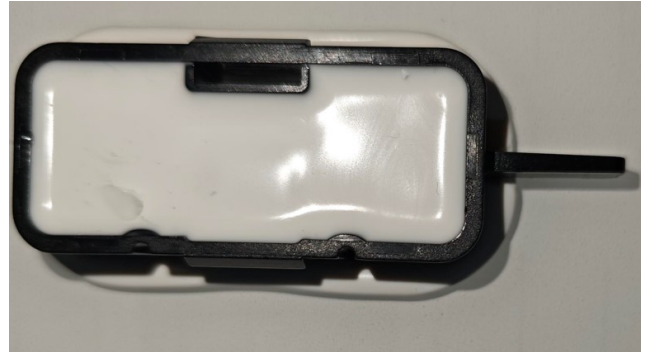
*Junction box (opened)*

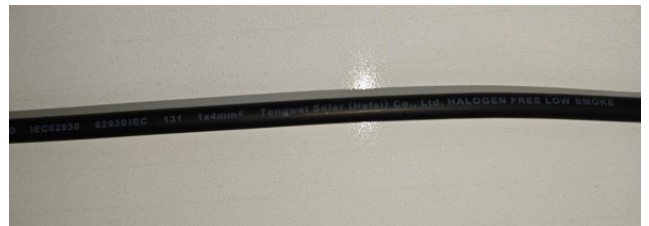
*Cable (62930 IEC 131 1x4.0mm<sup>2</sup>)*

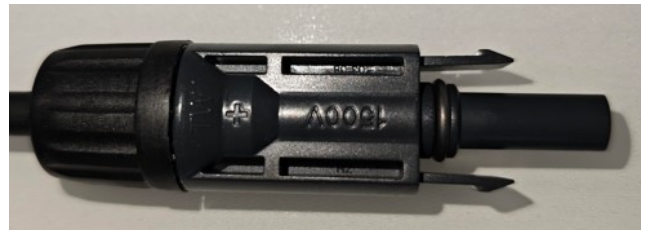
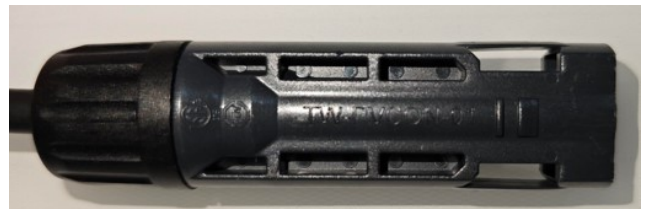
*Connectors (TW-PVCON-01)*

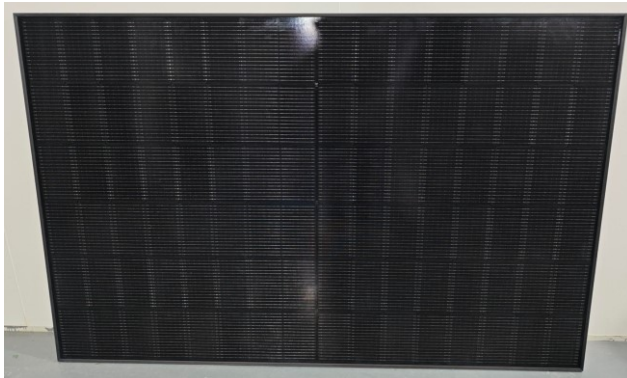
*Front overview*

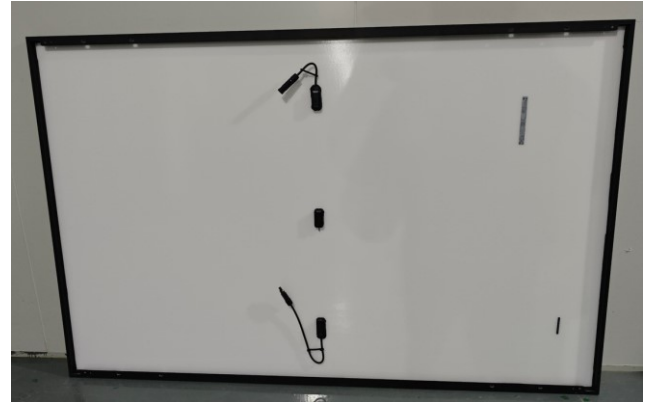
*Back overview*

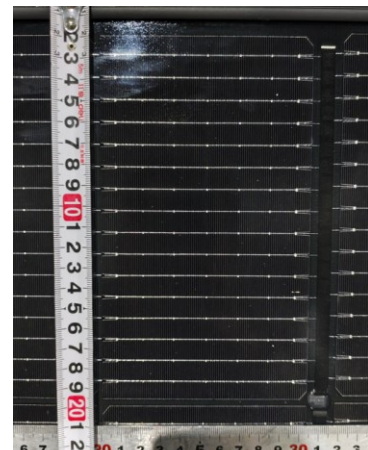
*Solar cell*

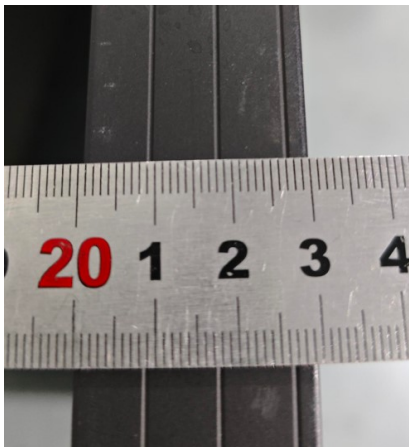
*Frame*

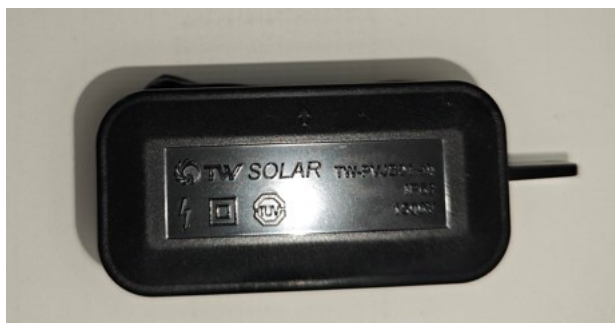
*Junction box (TW-PVJB01-ab)*

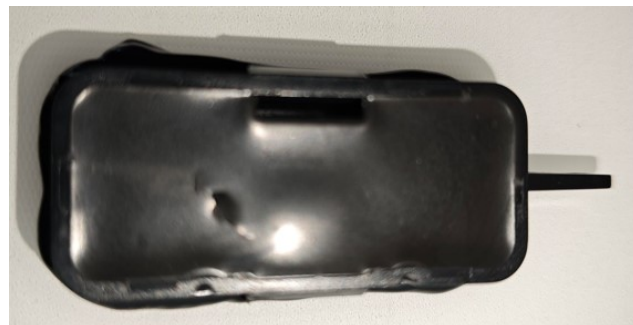
*Junction box (opened)*

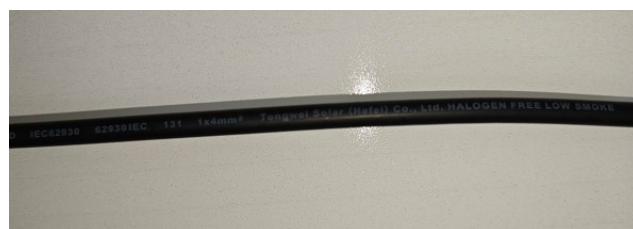
*Cable (62930 IEC 131 1x4.0mm<sup>2</sup>)*

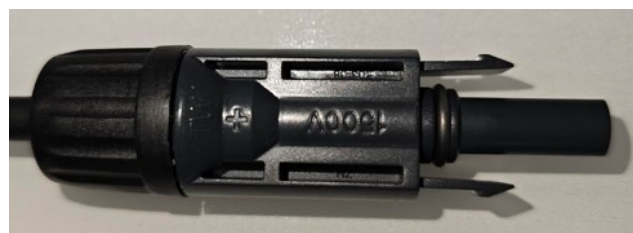
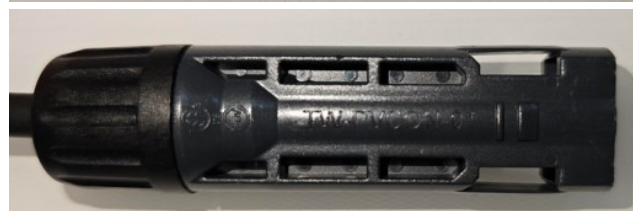
*Connectors (TW-PVCON-01)*
